**U.S. EPA REGION VIII
TECHNICAL ENFORCEMENT PROGRAM
RCRA CORRECTIVE ACTION ASSESSMENT REPORT**

Facility: ASARCO East Helena Plant
100 Smelter Road
East Helena, MT

Inspection Type: Corrective Action Assessment Inspection

Date: March 7, 2007

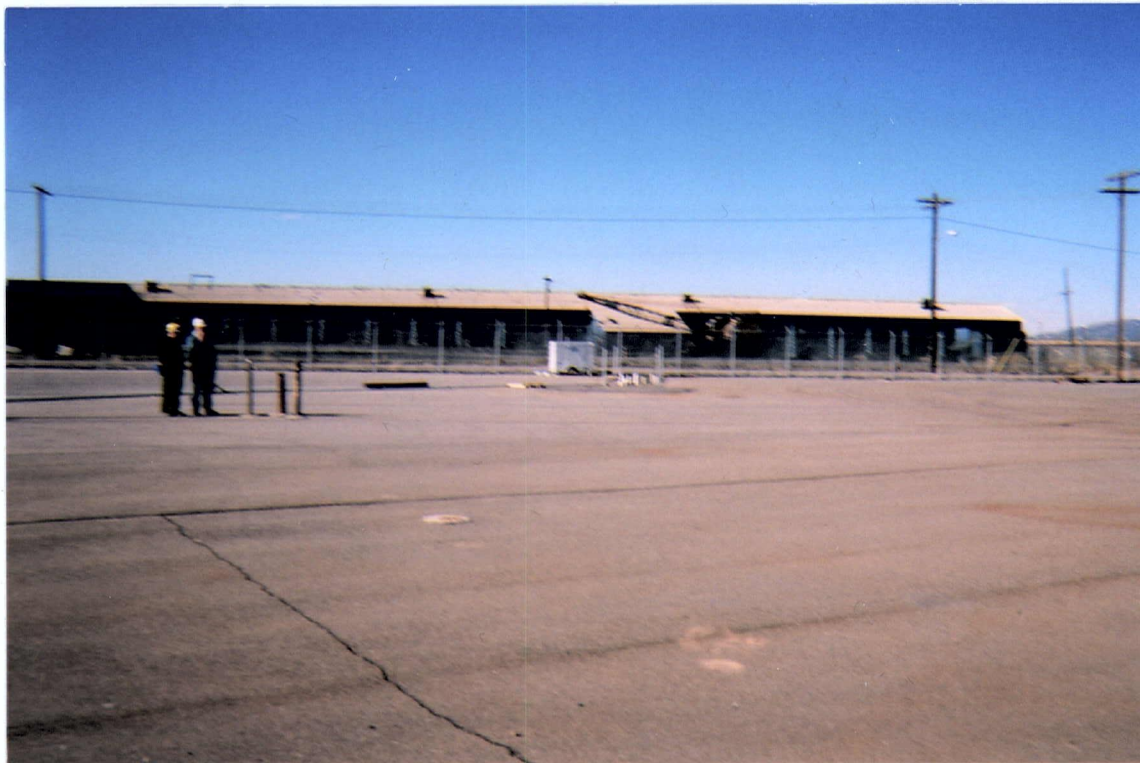
Roll 1, Photo 1; Facility: ASARCO East Helena Smelter; Subject: PRB Pilot-Scale Well Set-Up; Photographer: Linda Jacobson; Date: March 7, 2007

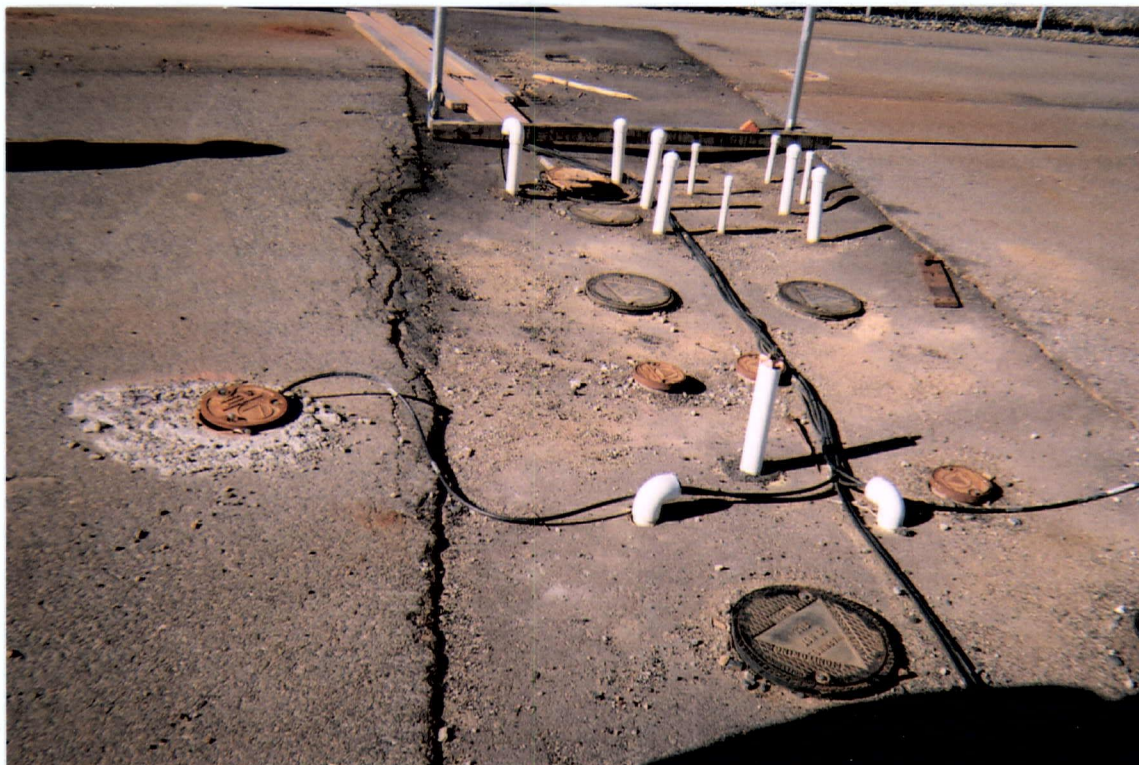
Roll 1, Photo 2; Facility: ASARCO East Helena Smelter; Subject: INL Resistivity Testing Cables; Photographer: Linda Jacobson; Date: March 7, 2007

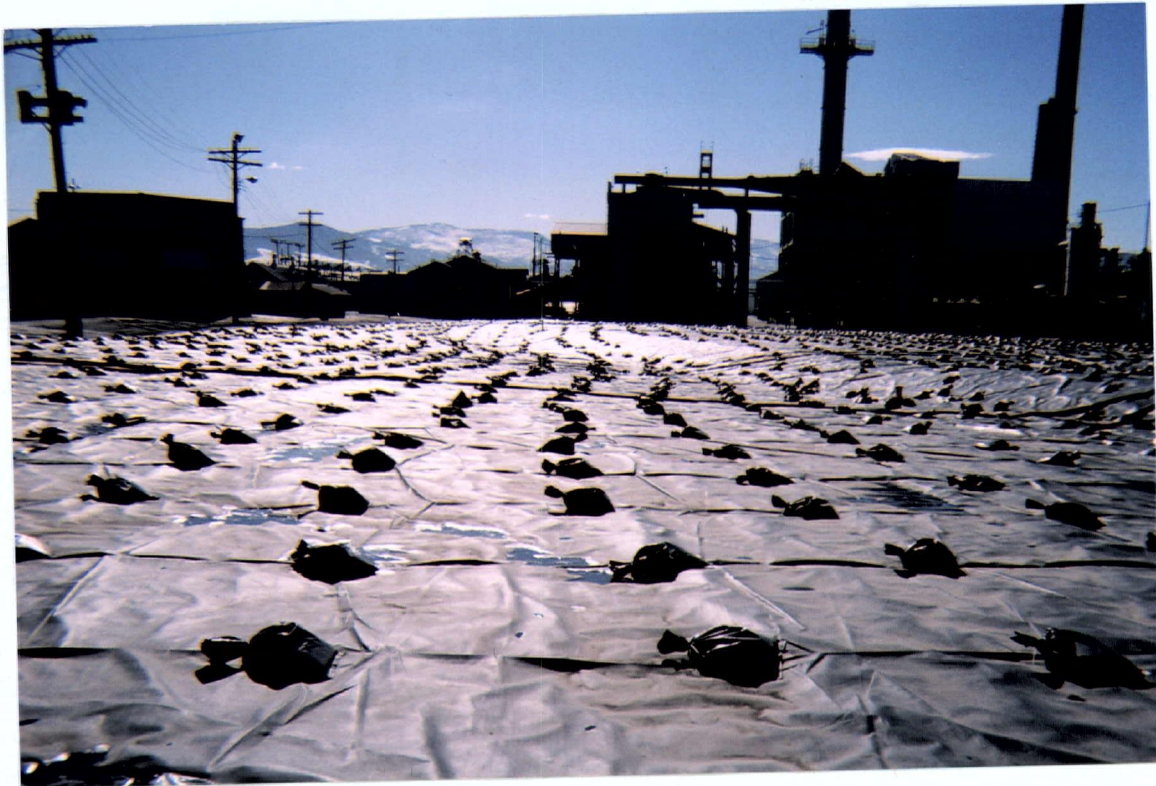
Roll 1, Photo 3; Facility: ASARCO East Helena Smelter; Subject: Temporary Cover of Dross Plant/Speiss Granulating Area; Photographer: Linda Jacobson; Date: March 7, 2006

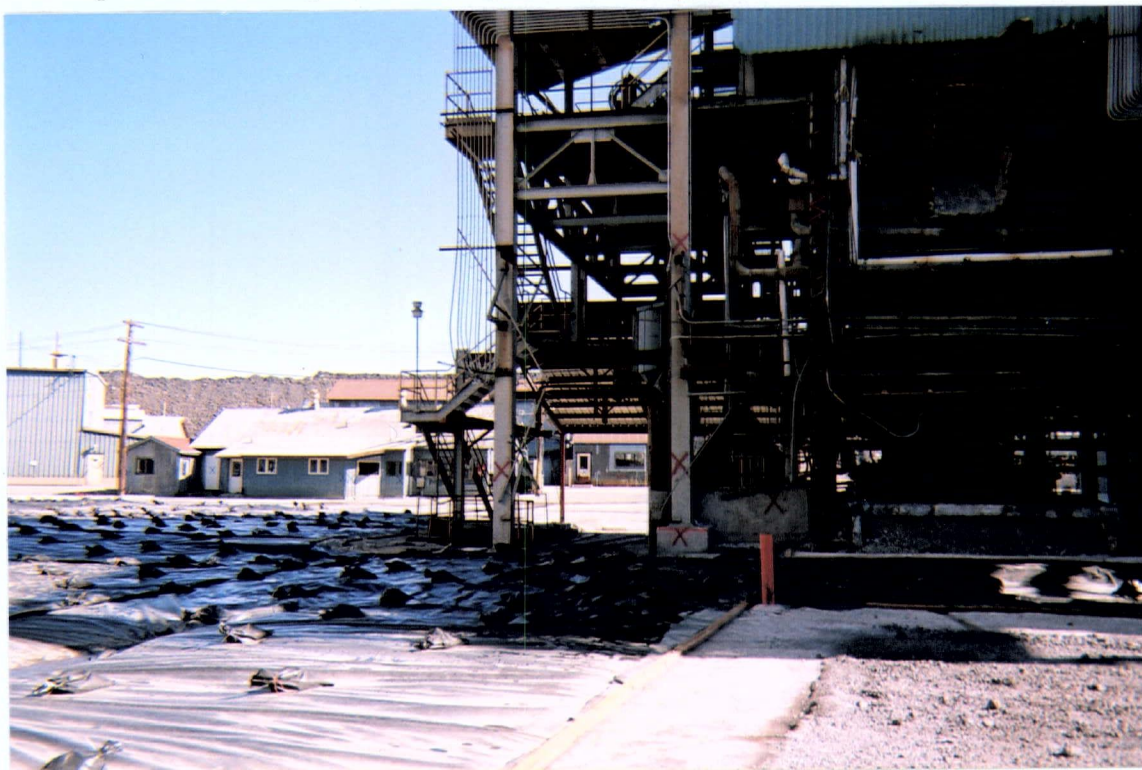
Roll 1, Photo 4; Facility: ASARCO East Helena Smelter; Subject: Blast Furnace Building; Photographer: Linda Jacobson; Date: March 7, 2007

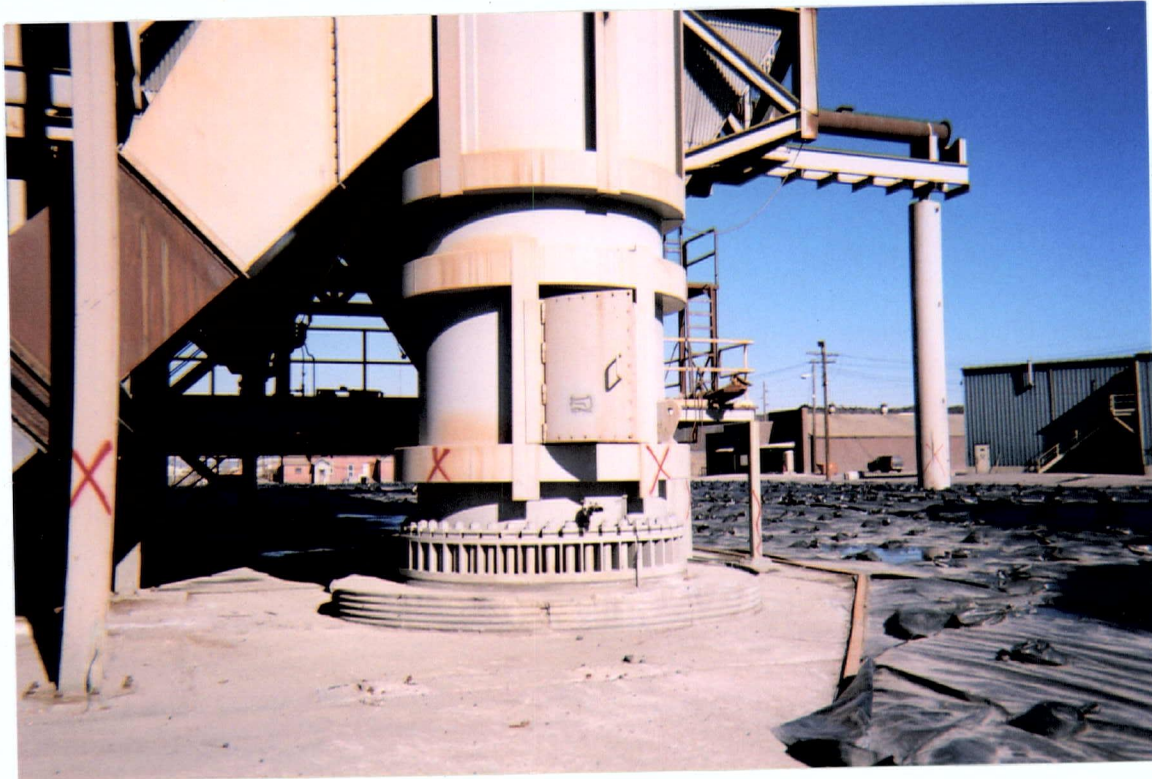
Roll 1, Photo 5; Facility: ASARCO East Helena Smelter; Subject: Dross Plant Baghouse Base;
Photographer: Linda Jacobson; Date: March 7, 2007

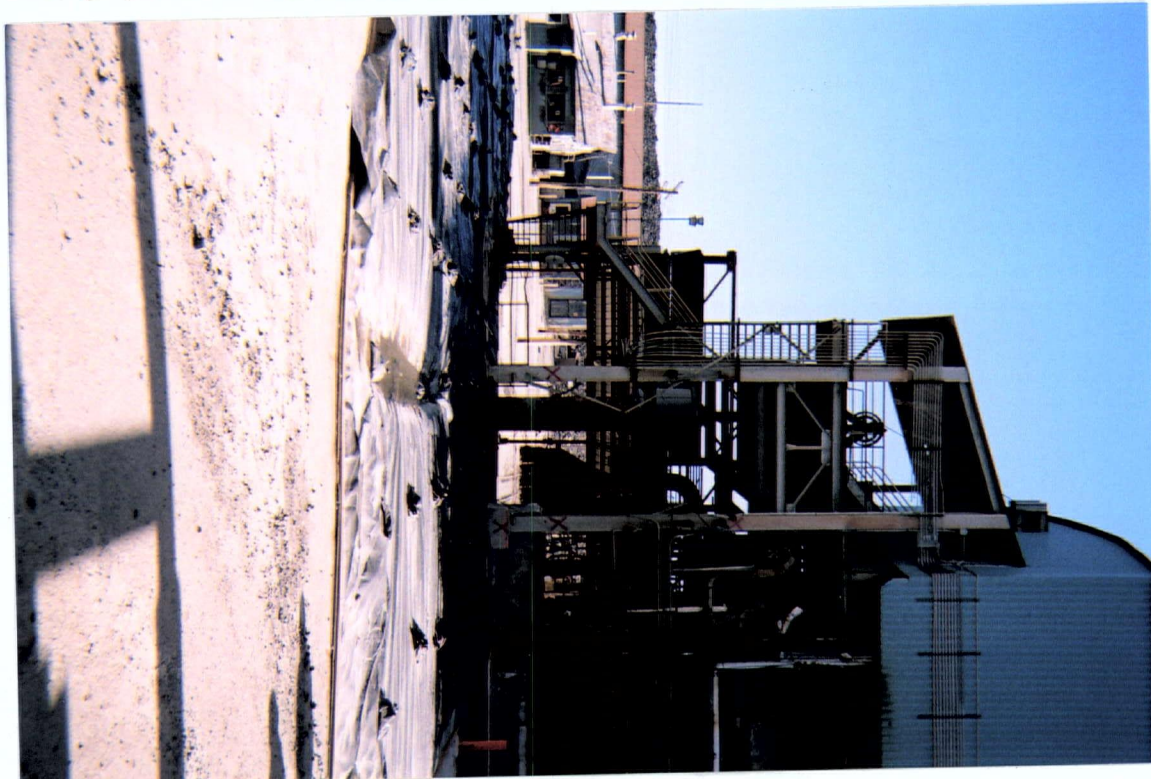
Roll 1, Photo 6; Facility: ASARCO East Helena Smelter; Subject: Blast Furnace Building;
Photographer: Linda Jacobson; Date: March 7, 2007

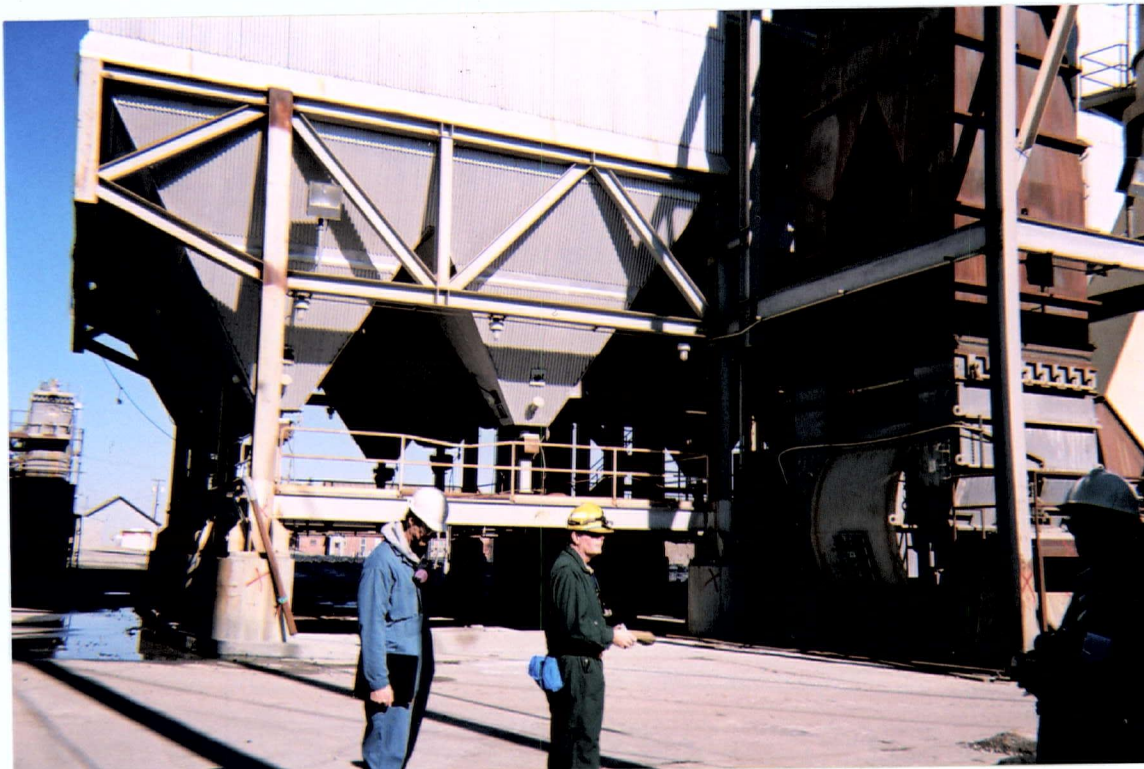
Roll 1, Photo 7; Facility: ASARCO East Helena Smelter; Subject: Dross Baghouse & Duct Support; Photographer: Linda Jacobson; Date: March 7, 2007

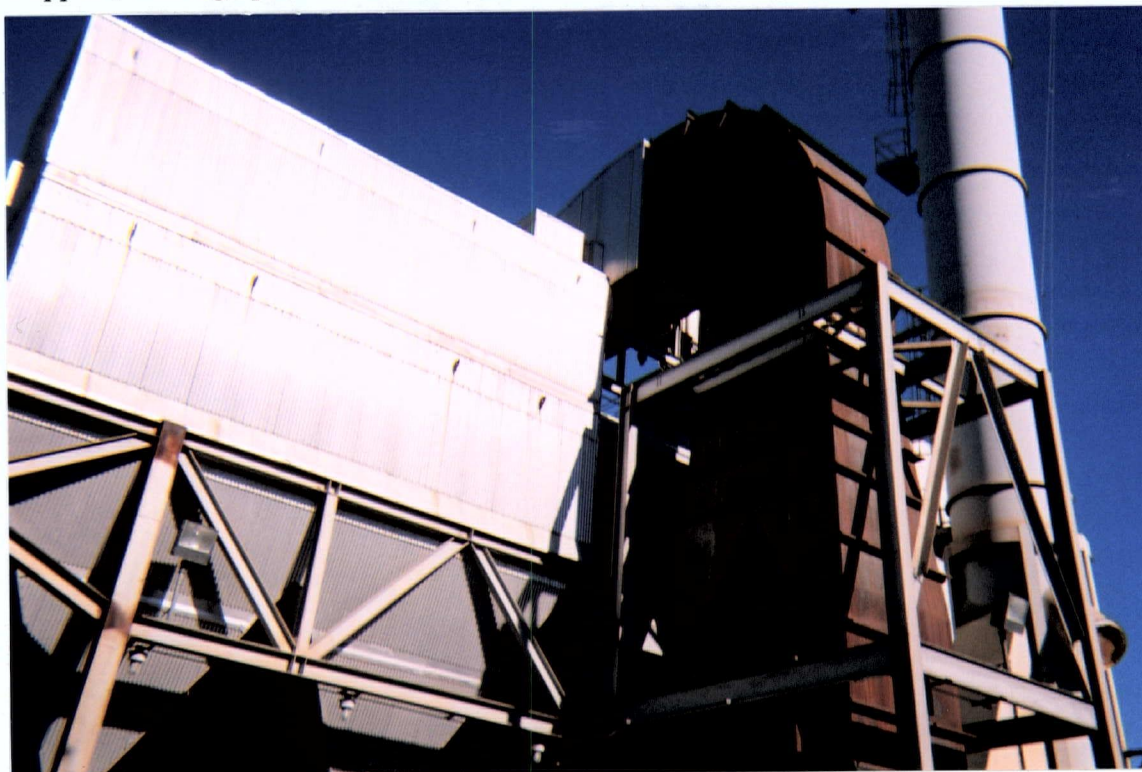
Roll 1, Photo 8; Facility: ASARCO East Helena Smelter; Subject: Dross Plant Baghouse; Photographer: Linda Jacobson; Date: March 7, 2007

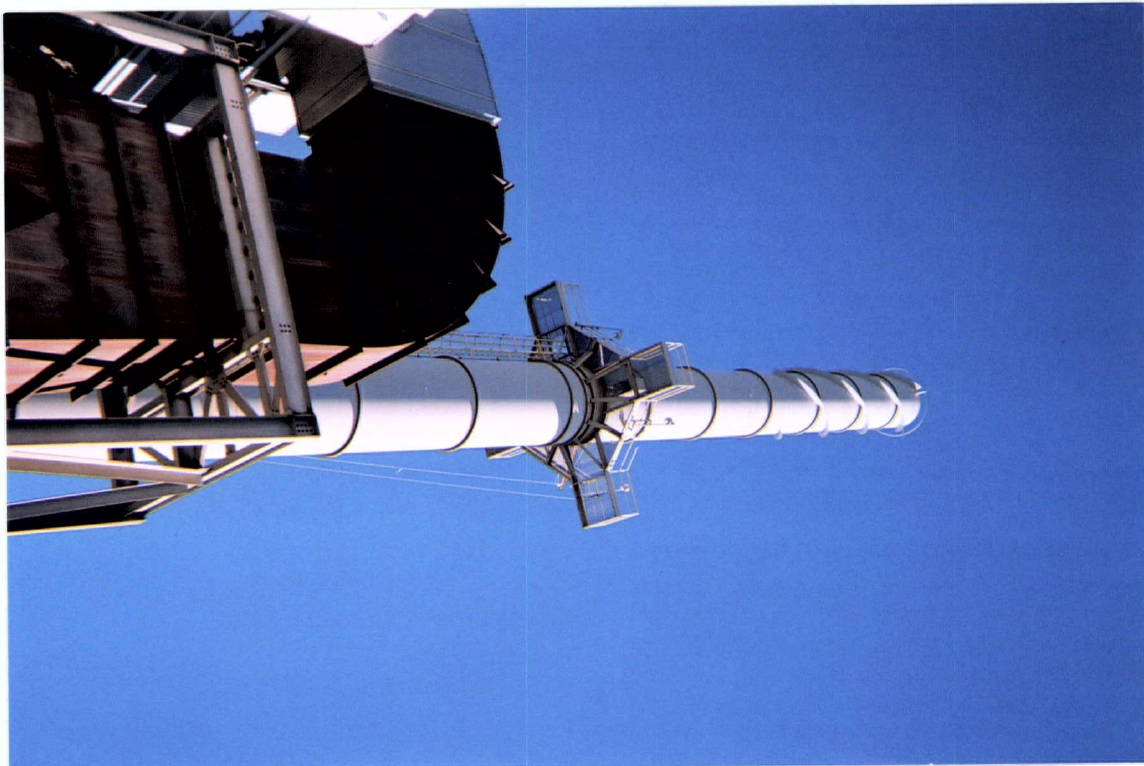
Roll 1, Photo 9; Facility: ASARCO East Helena Smelter; Subject: Dross Plant Baghouse Stack; Photographer: Linda Jacobson; Date: March 7, 2007

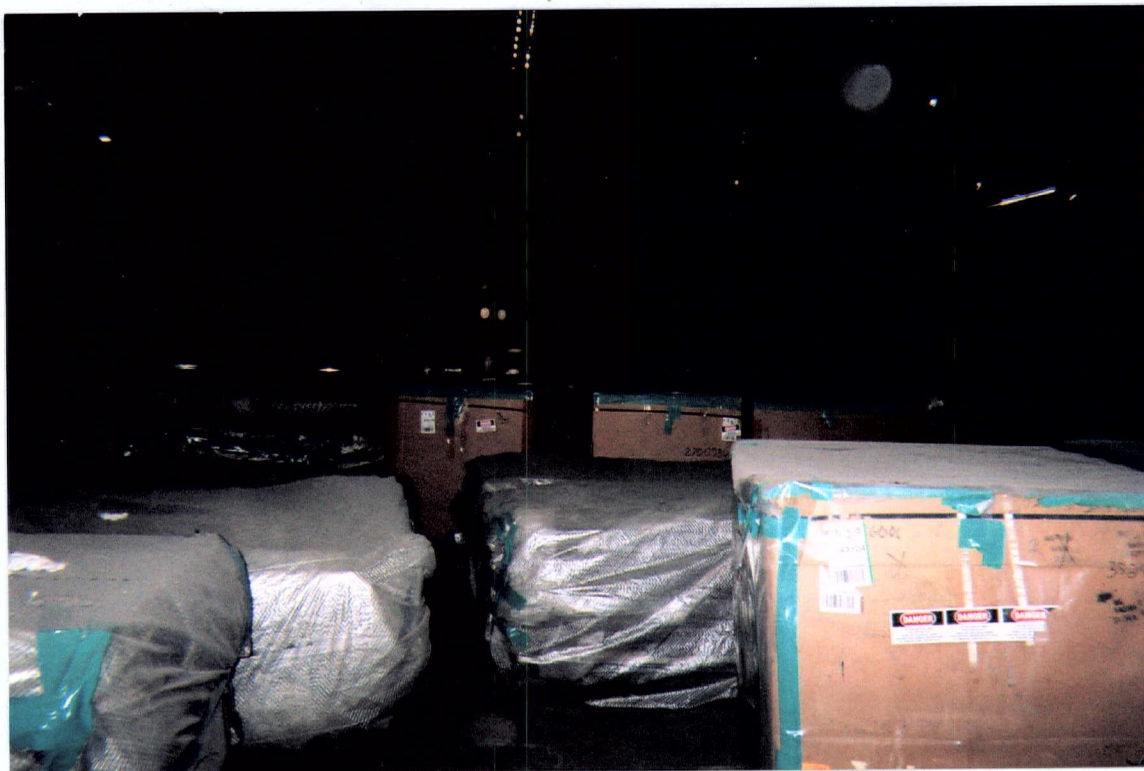
Roll 1, Photo 10; Facility: ASARCO East Helena Smelter; Subject: Asbestos Storage in Direct Smelt Building; Photographer: Linda Jacobson; Date: March 7, 2007

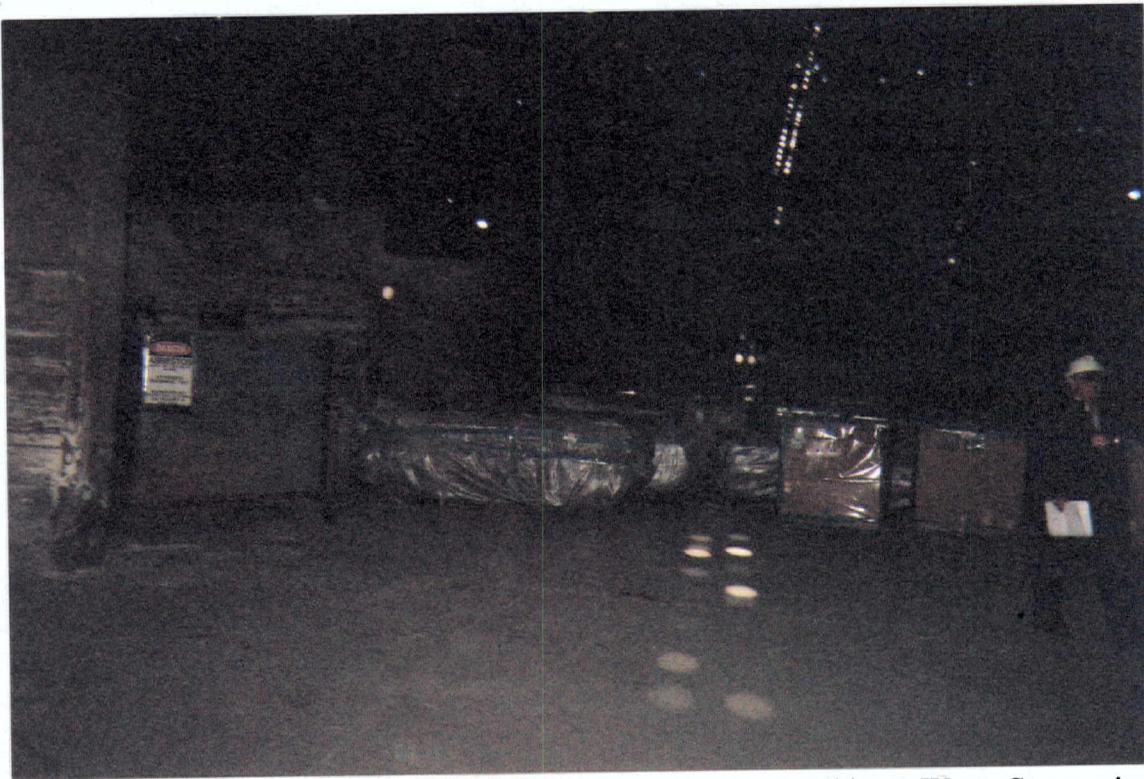
Roll 1, Photo 11; Facility: ASARCO East Helena Smelter; Subject: Waste Storage in Direct Smelt Building; Photographer: Linda Jacobson; Date: March 7, 2007

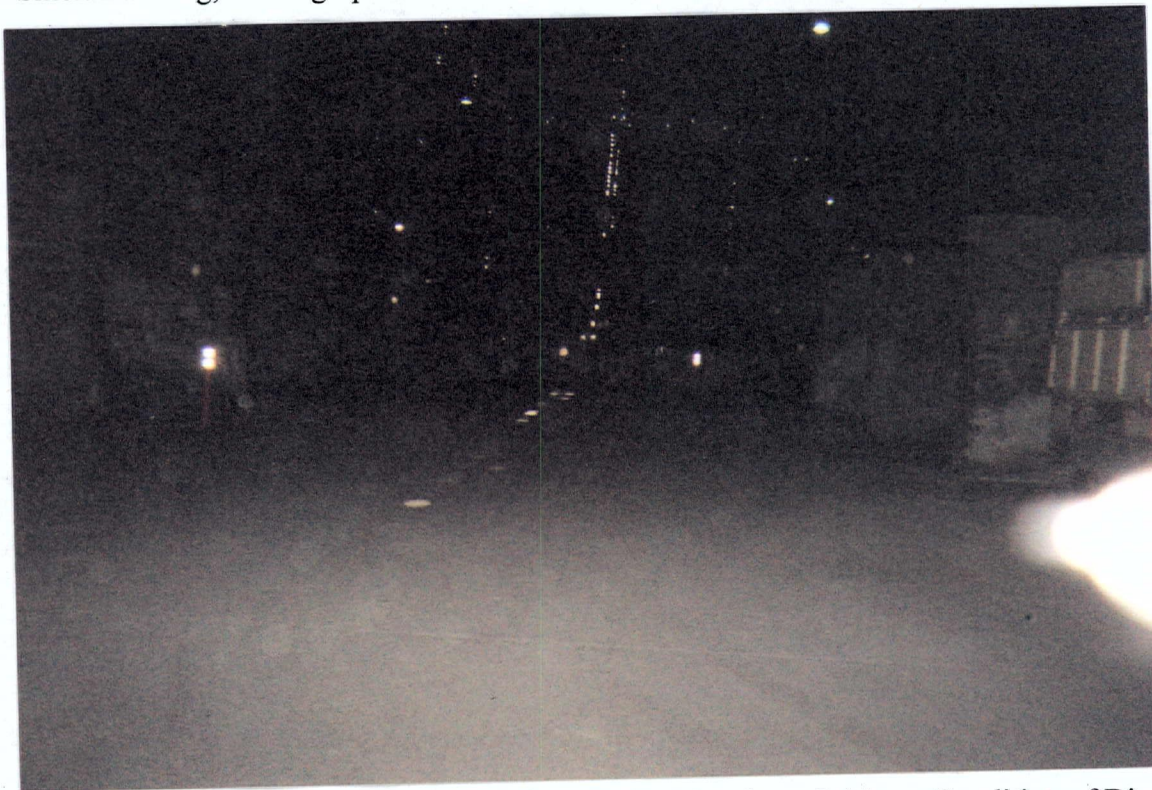
Roll 1, Photo 12; Facility: ASARCO East Helena Smelter; Subject: Condition of Direct Smelt Building Roof as Noted by Light Circles from Holes; Photographer: Linda Jacobson; Date: March 7, 2007

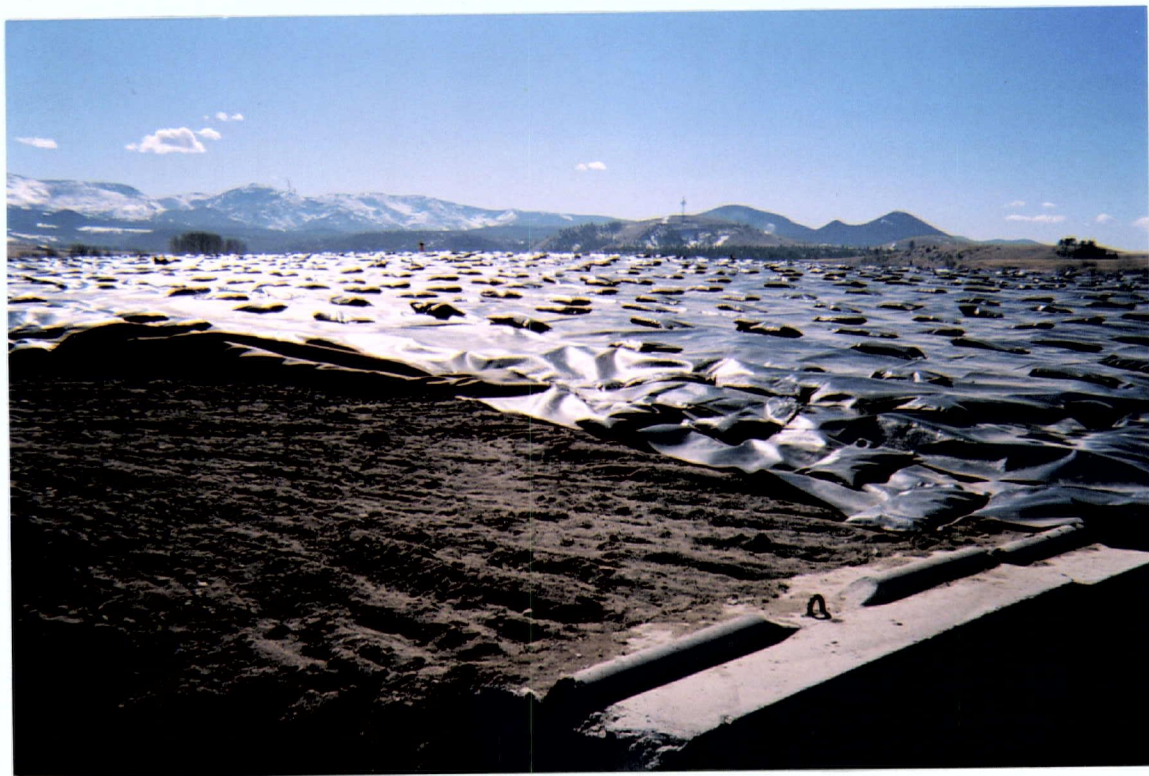
Roll 1, Photo 13; Facility: ASARCO East Helena Smelter; Subject: Temporary Cap at Former APSD; Photographer: Linda Jacobson; Date: March 7, 2007

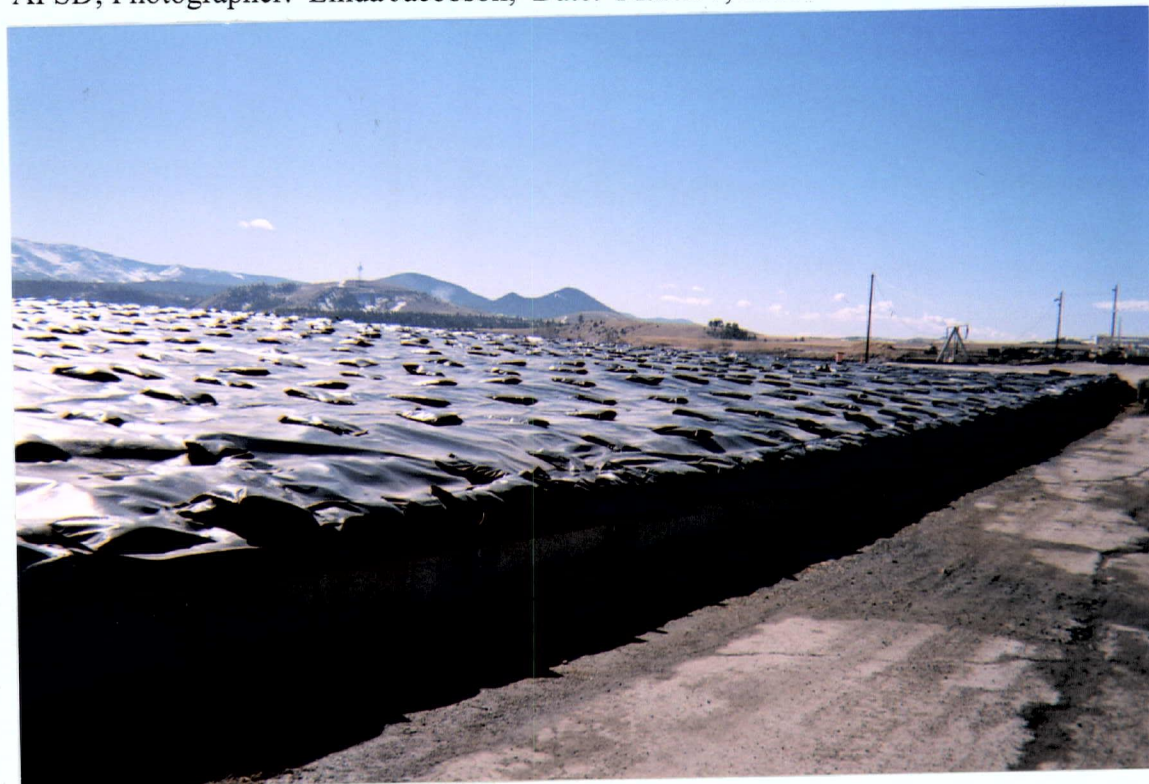
Roll 1, Photo 14; Facility: ASARCO East Helena Smelter; Subject: Temporary Cap at Former APSD; Photographer: Linda Jacobson; Date: March 7, 2007

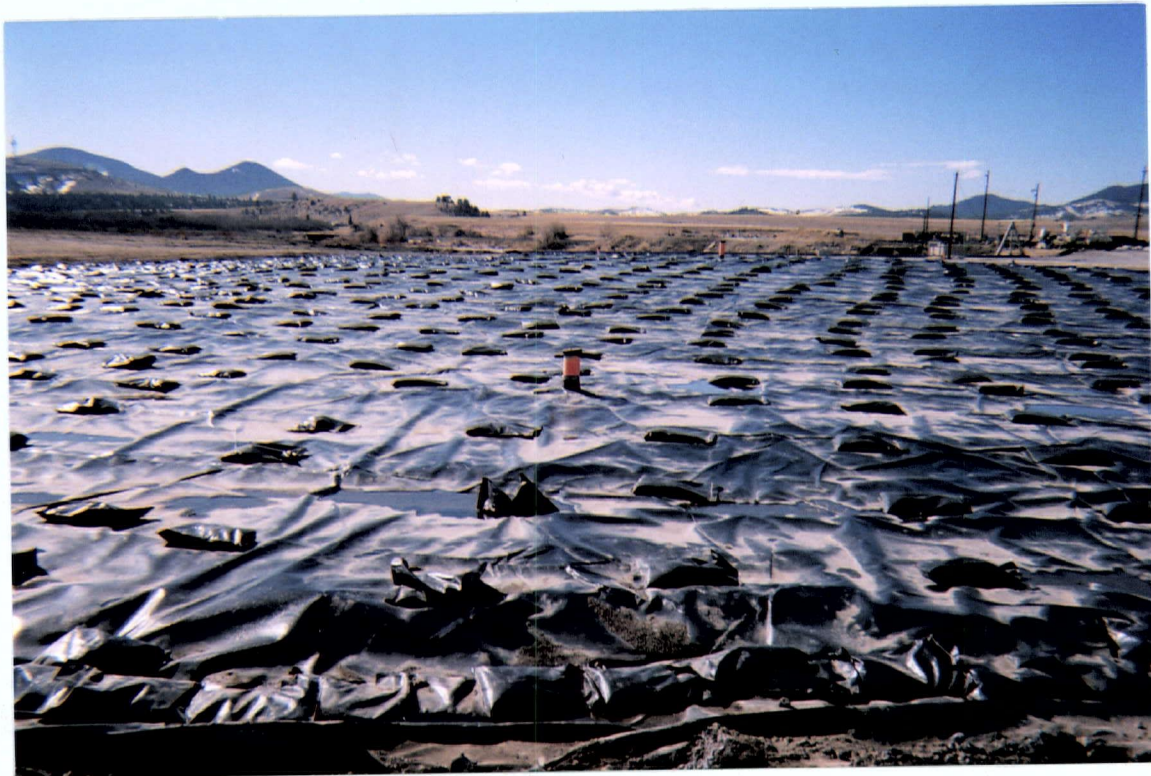
Roll 1, Photo 15; Facility: ASARCO East Helena Smelter; Subject: Temporary Cap at Former APSD; Photographer: Linda Jacobson; Date: March 7, 2007

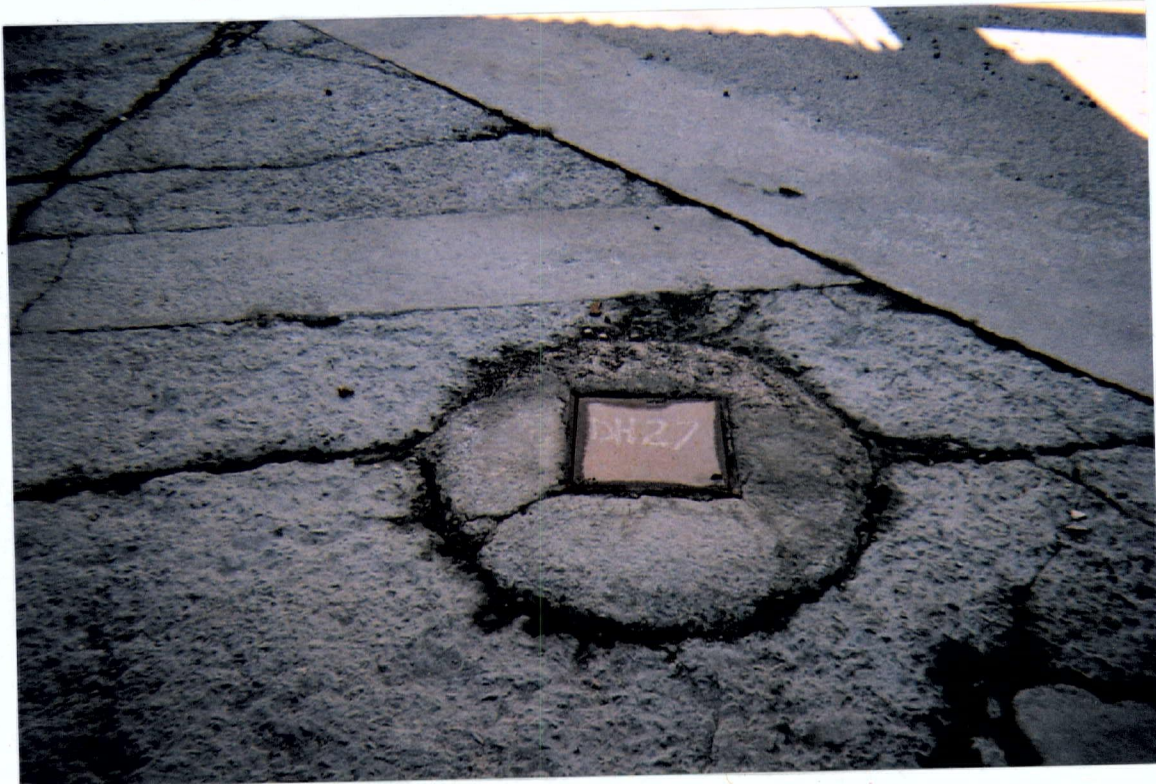
Ms. Jacobson spot checked the physical condition of seven of the site wells, checking to see if the casings were vertical, the condition of the well apron and whether the wells were locked and labeled. One of the wells, the ASARCO permeable reactive barrier (PRB) well located next to the slag pile, was not locked. Wells DH-32, DH-37, DH-27, DH-44, DH-40, and DH-33 appeared to be in good physical condition. Well DH-29 was vertical, locked, and labeled but had a crack in the well apron; however, this well is targeted to be properly abandoned this summer.

Roll 1, Photo 16; Facility: ASARCO East Helena Smelter; Subject: Well DH-27
Photographer: Linda Jacobson; Date: March 7, 2007

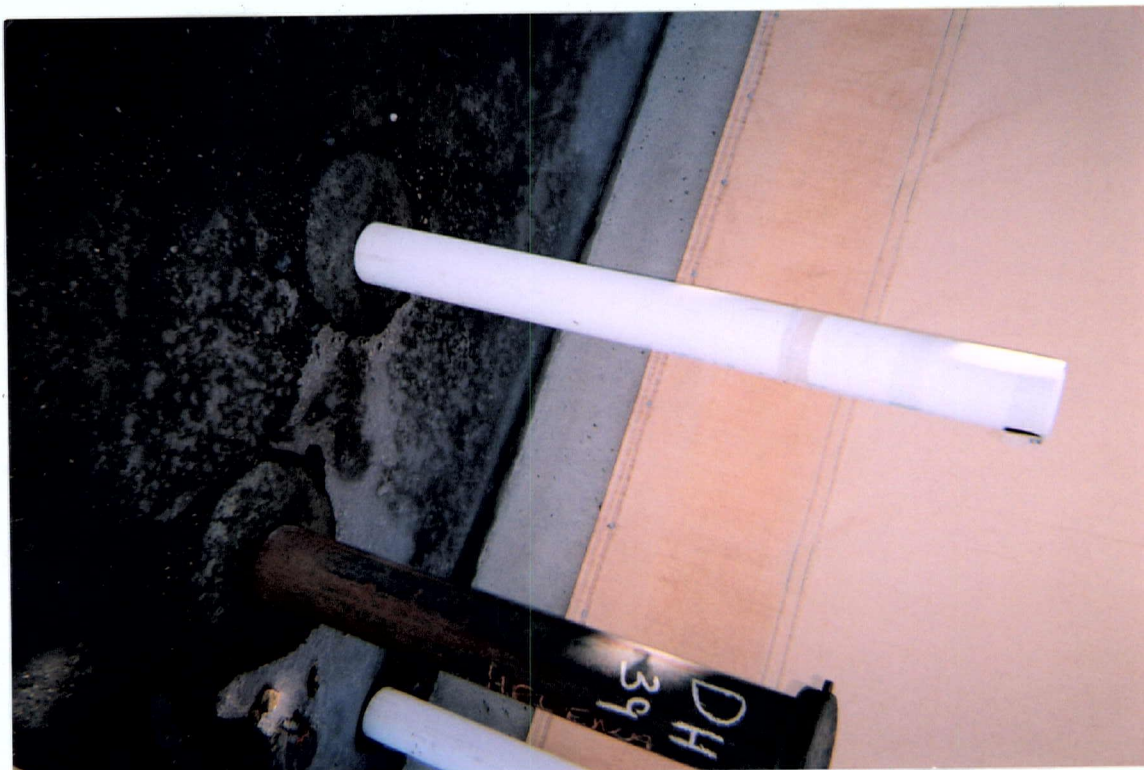
Roll 1, Photo 17; Facility: ASARCO East Helena Smelter; Subject: Well DH-39;
Photographer: Linda Jacobson; Date: March 7, 2007

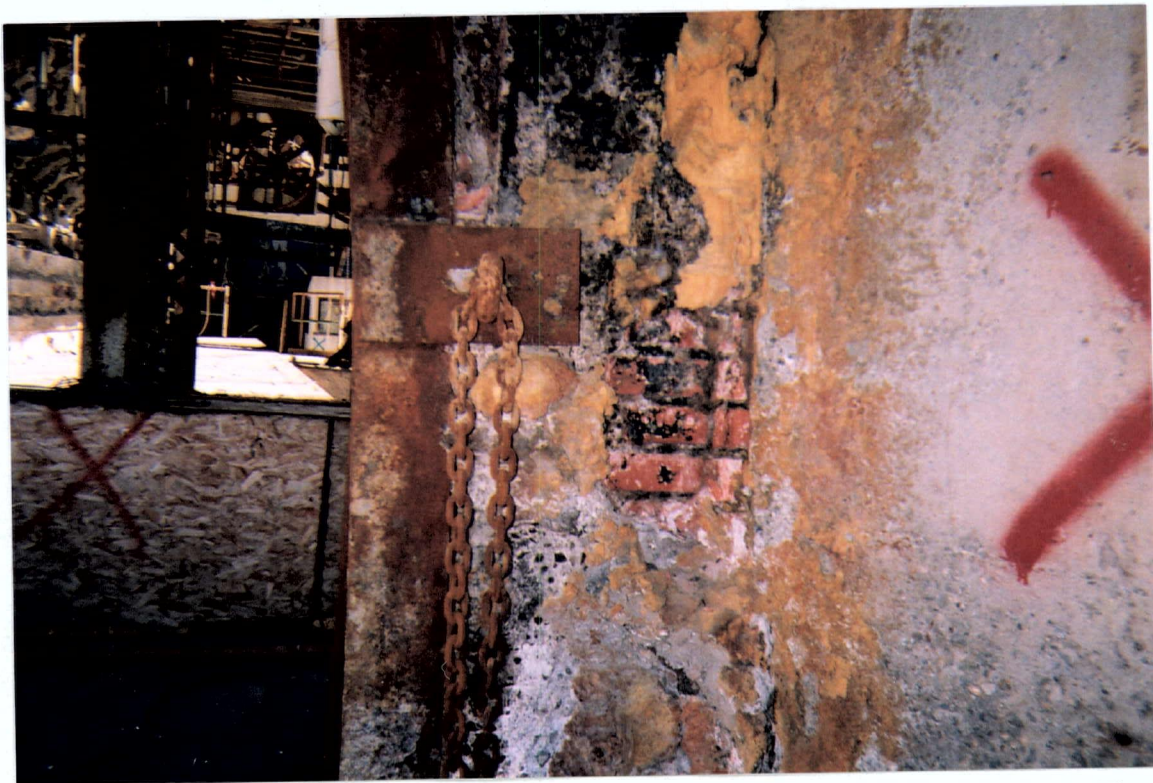
Roll 1, Photo 18: Facility: ASARCO East Helena Smelter; Subject: Asbestos on Flue;
Photographer: Linda Jacobson; Date: March 7, 2007

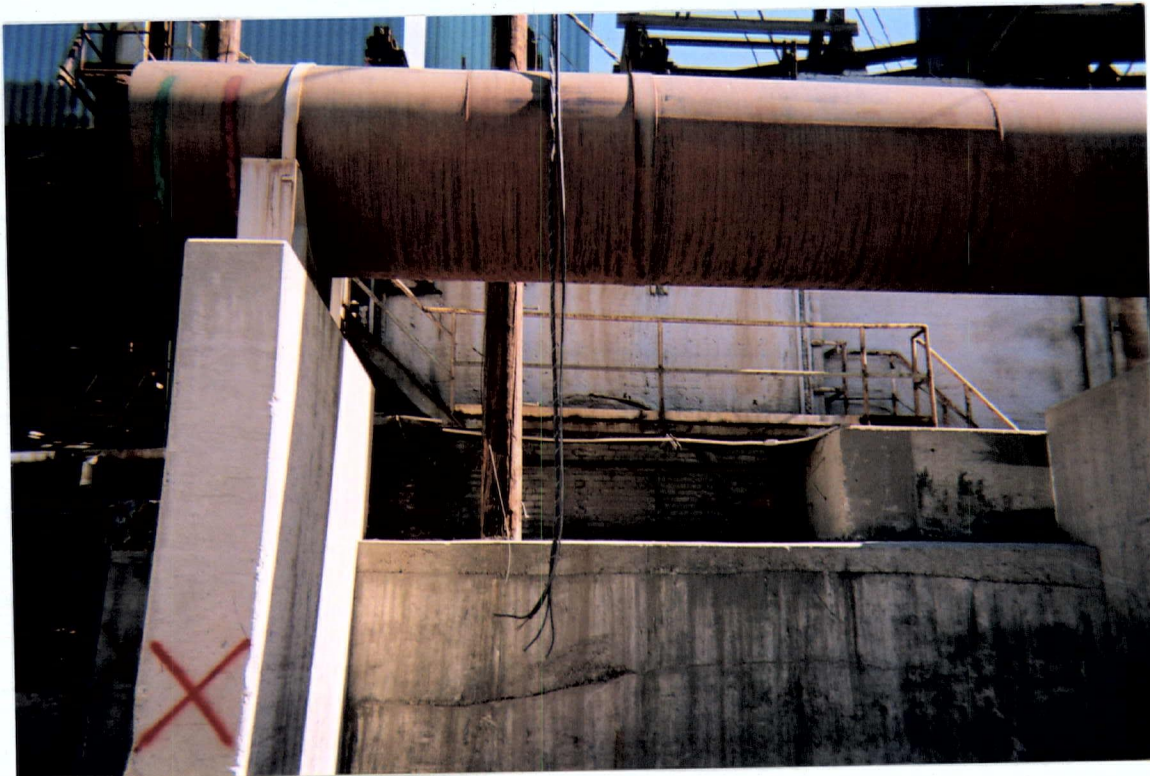
Roll 1, Photo 19; Facility: ASARCO East Helena Smelter; Subject: Walls of Flue;
Photographer: Linda Jacobson; Date: March 7, 2007

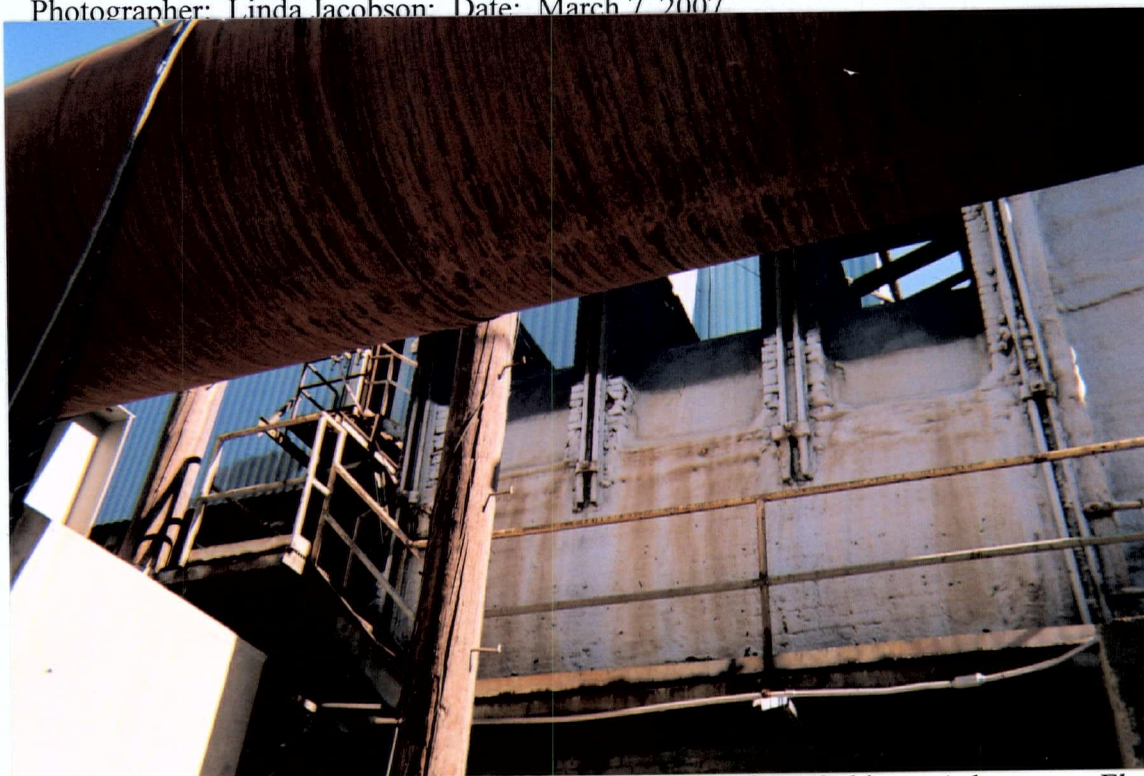
Roll 1, Photo 20; Facility: ASARCO East Helena Smelter; Subject: Asbestos on Flue;
Photographer: Linda Jacobson; Date: March 7, 2007

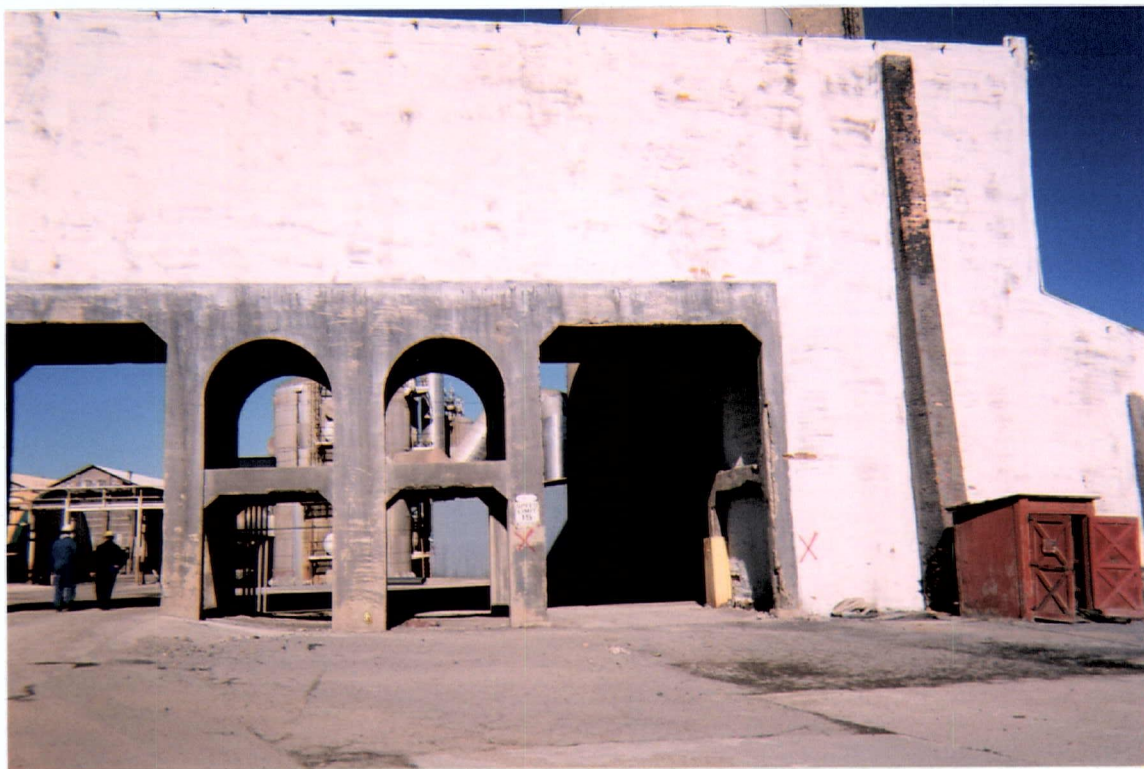
Roll 1, Photo 21; Facility: ASARCO East Helena Smelter; Subject: Flue; Photographer: Linda Jacobson; Date: March 7, 2007

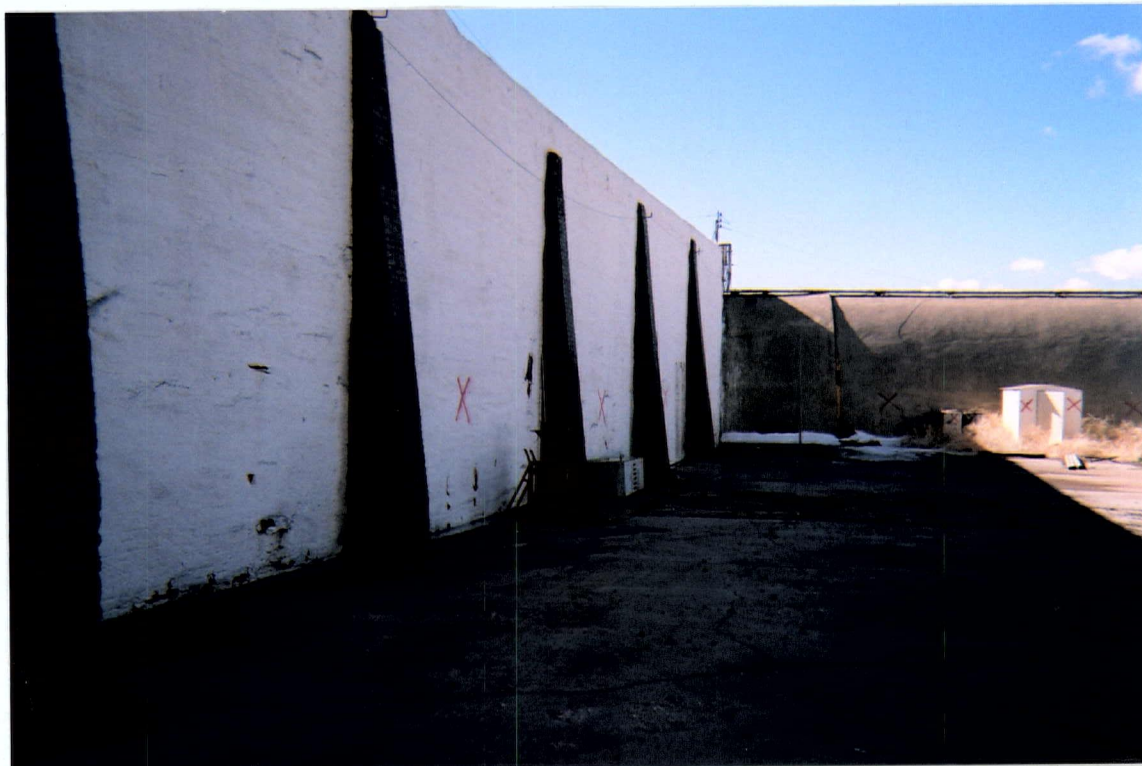
Roll 1, Photo 22; Facility: ASARCO East Helena Smelter; Subject: Transition to Monier Flue; Photographer: Linda Jacobson; Date: March 7, 2007

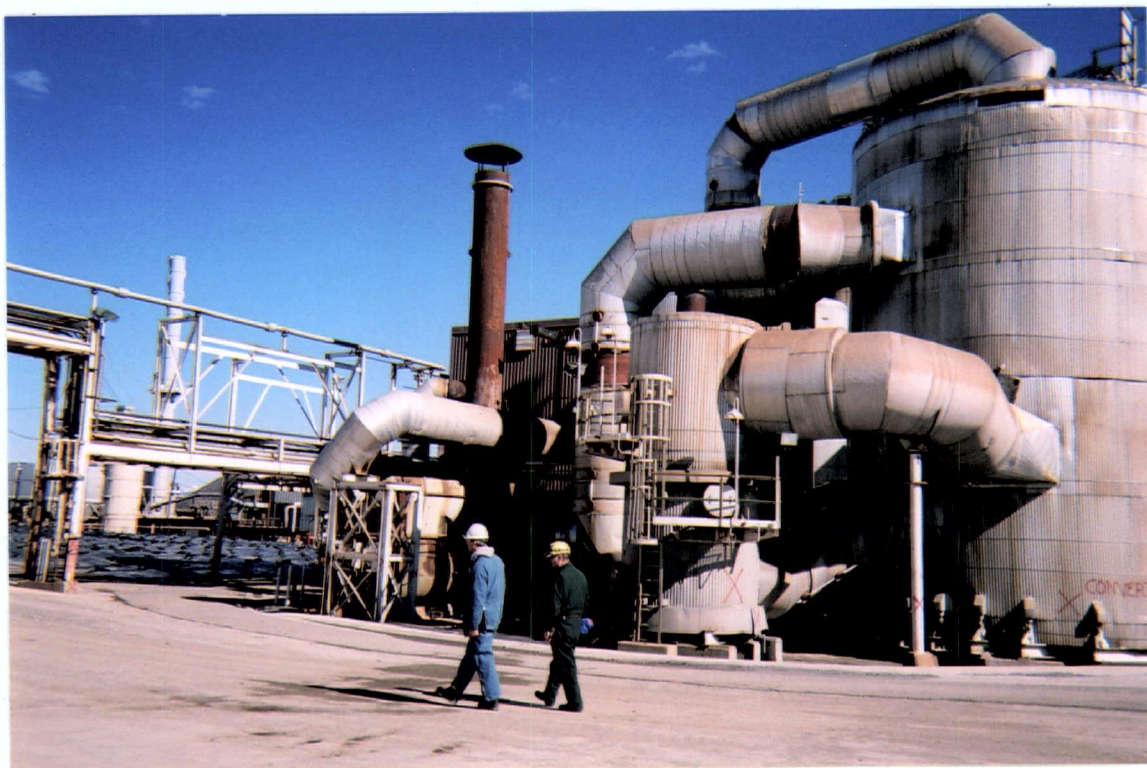
Roll 1, Photo 23; Facility: ASARCO East Helena Smelter; Subject: Acid Plant & Piping;
Photographer: Linda Jacobson; Date: March 7, 2007

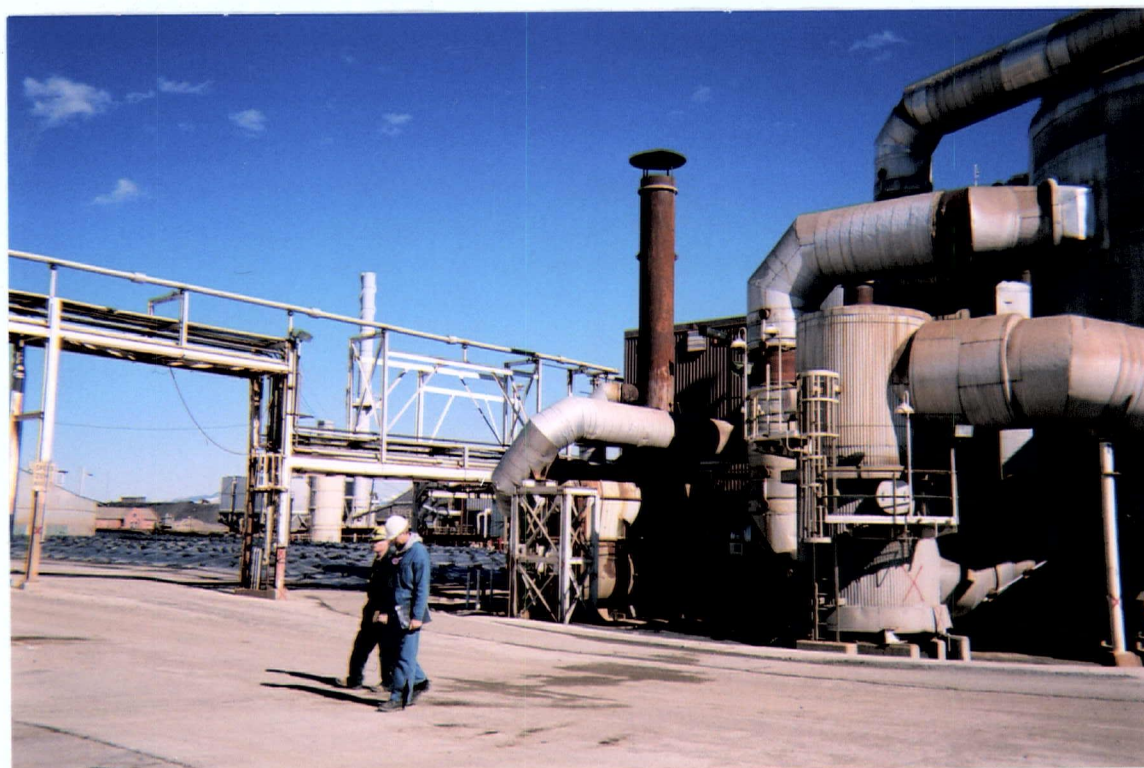
Roll 1, Photo 24; Facility: ASARCO East Helena Smelter; Subject: Acid Plant & Piping;
Photographer: Linda Jacobson; Date: March 7, 2007
